Smoke and Dye Testing Summary

High Level Sewershed

Test ID	Test Type	Date Inspected	Company / Super.	Blower MH	Ground Condition	Notification Made?	Total Length
S1028-285	Smoke	9/9/2009	ADS/TM	S09II1008MH	Dry	Yes	874.46

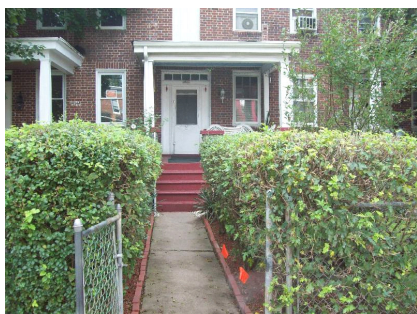
Picture \S1028-285-OB01-P01.jpg

Source Service Lateral

Location Yard - front

Comments Smoke from service lateral in front yard. 4624 Reisterstown Rd.

Comments Front of house, 4624 Reisterstown Rd.

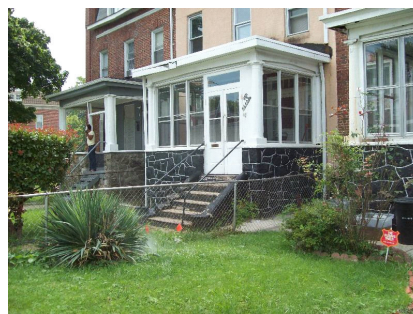
Picture \S1028-285-OB02-P01.jpg

Source Service Lateral

Location Yard - front

Comments Smoke from service lateral in front yard. 4642 Reisterstown Rd.

Comments Front of house, 4642 Reisterstown Rd.
